Preliminary Engineering Report

NuTech Orchard Removal, LLC

DuraTech Industries International, Inc.

Case No.: 3:18-cv-00256-DLH-ARS
United States District Court
District of North Dakota
Eastern Division

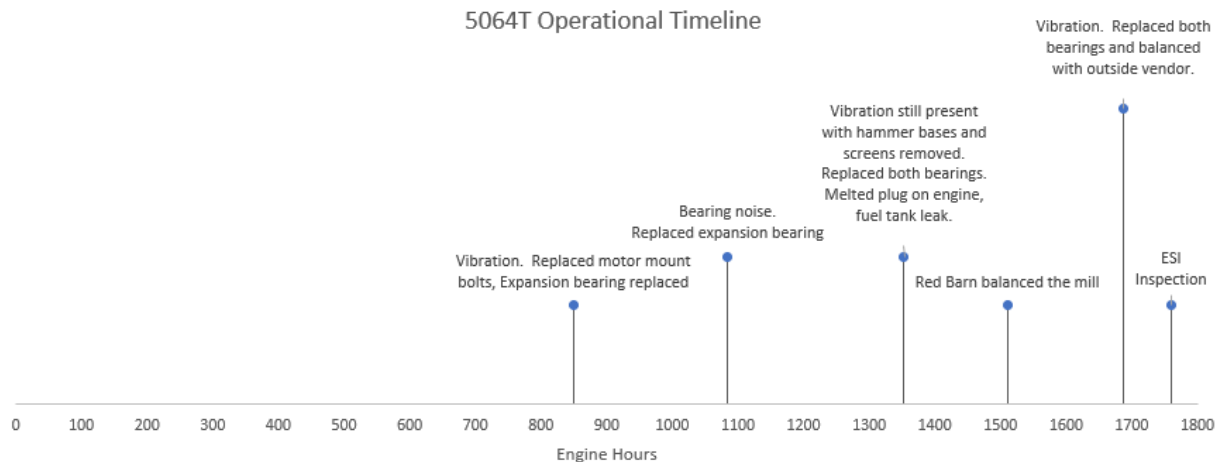
9. Thereafter, replacement bearings began failing at much shorter intervals: 235, 269, and 334 hours respectively for the non-pulley-side bearing (Figure 1). The life of a bearing averaged approximately 280 hours or about one-third the life of the original

part. The pulley-side bearing was replaced at or near the same time that the non-pulley side bearing was replaced.

Figure 1: Timeline showing operational repairs verses engine hours.
